GZA  
GeoEnvironmental, Inc.

June 29, 2009  
GZA File No. 01.0170142.00

Re: Task 3 Dam Assessment Report  
Project #0-381  
Marshall Steam Station Coal Ash Retention Dam  
Catawba County, North Carolina

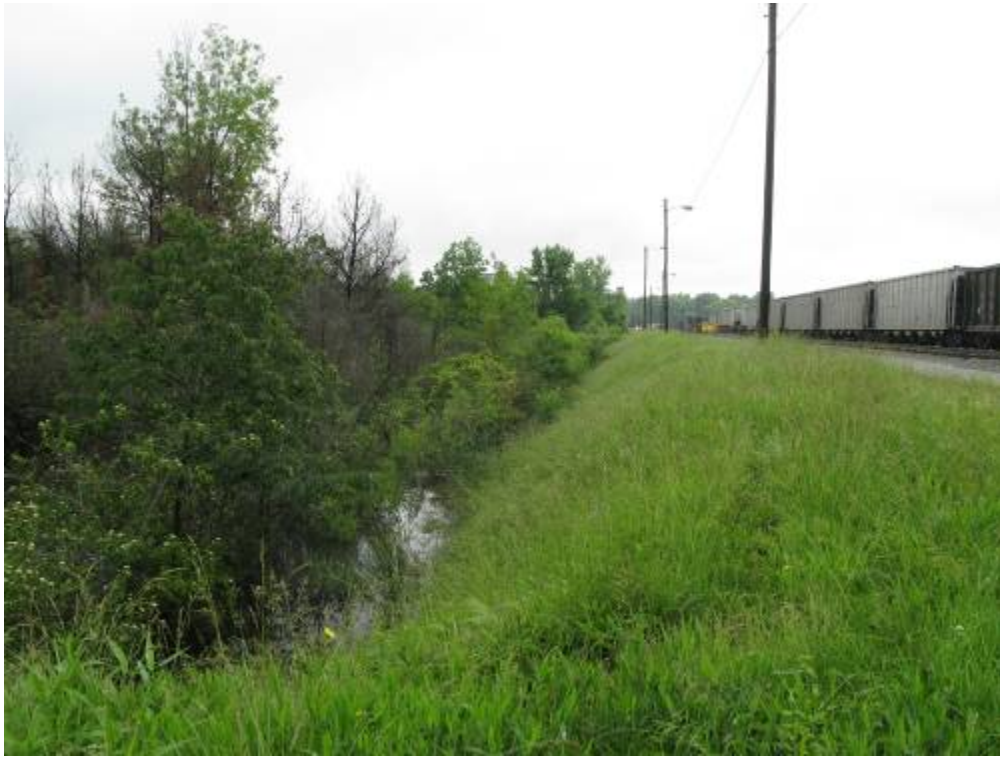
**Photo 1: Upstream view of dam from south end of impoundment. Note heavy vegetation at upstream toe.**

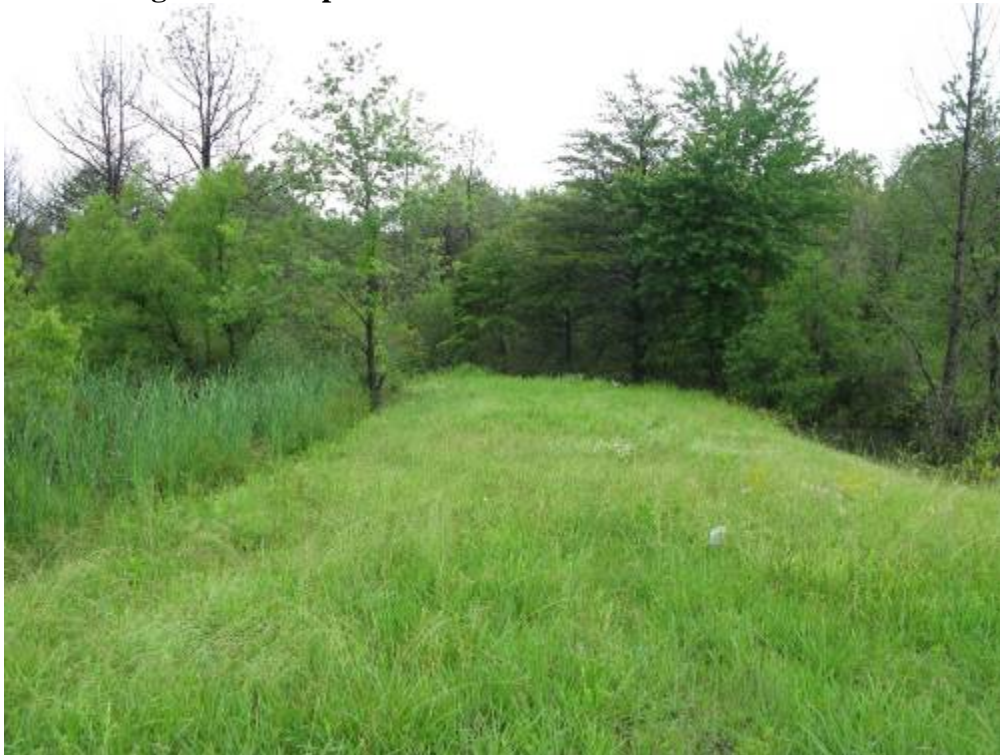
**Photo 2: Finger dike extending from upstream slope near the south end of embankment. Note heavy vegetation.**

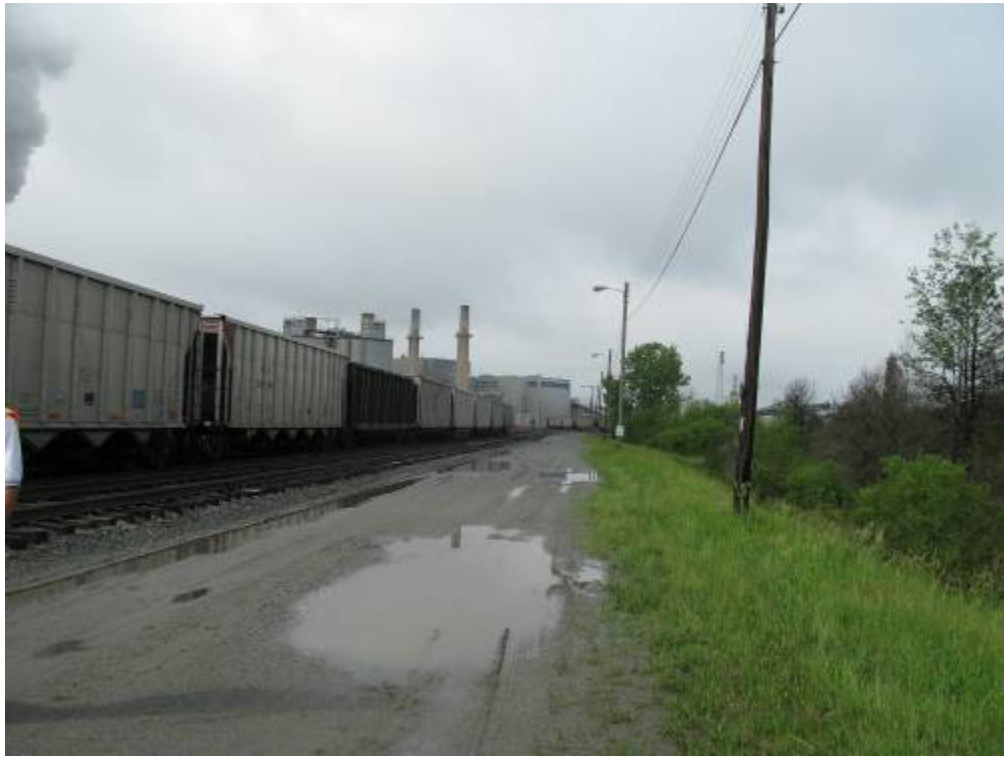
**Photo 3: South end of crest road, looking south towards the plant. Note the coal cars, the elevation of track w/r to the crest road, and the ponding of surface water.**

1. Repair of surface drainage system and grading including minor depressions found on the crest.
2. Investigate seeps at the downstream toe in dry weather, with repairs designed by a professional engineer and construction by a contractor experienced in dam repair.

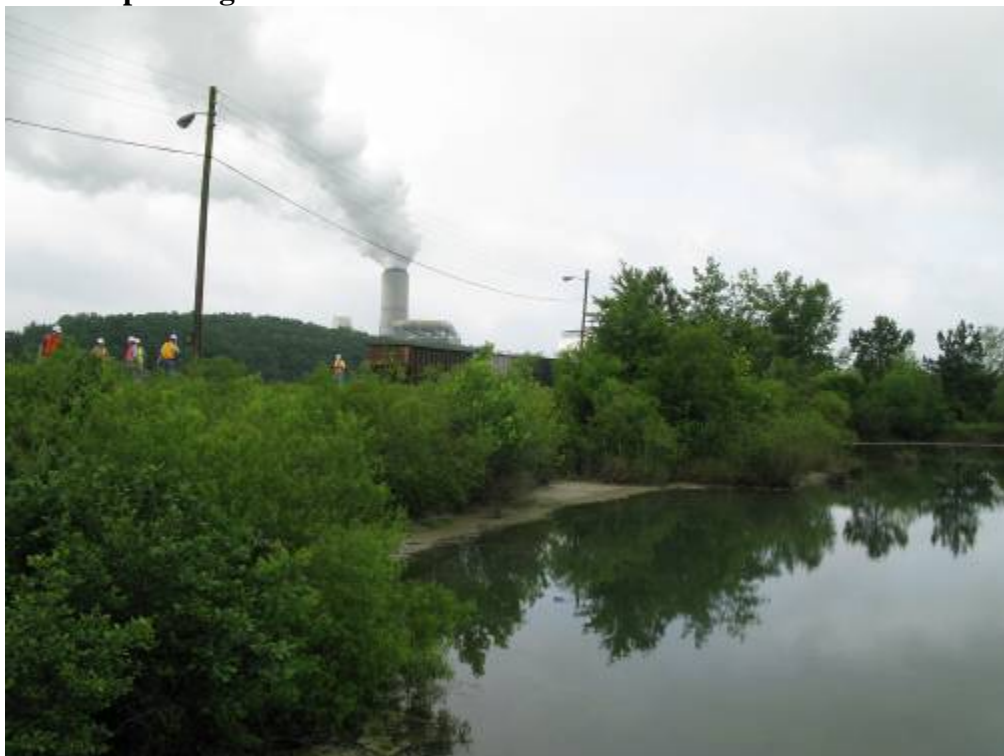
**Photo 4: Upstream face on southern end of dam. Note vegetation growth at toe and finger dike on right.**

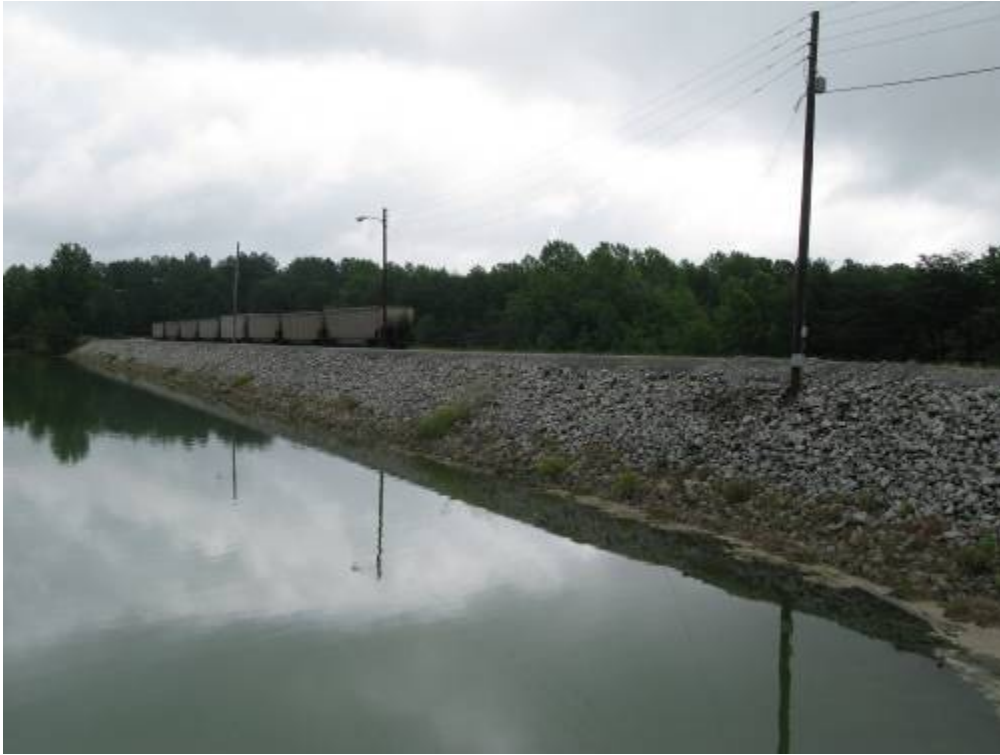
**Photo 5: Upstream slope north of Discharge Tower. Note the rip rap slope.**

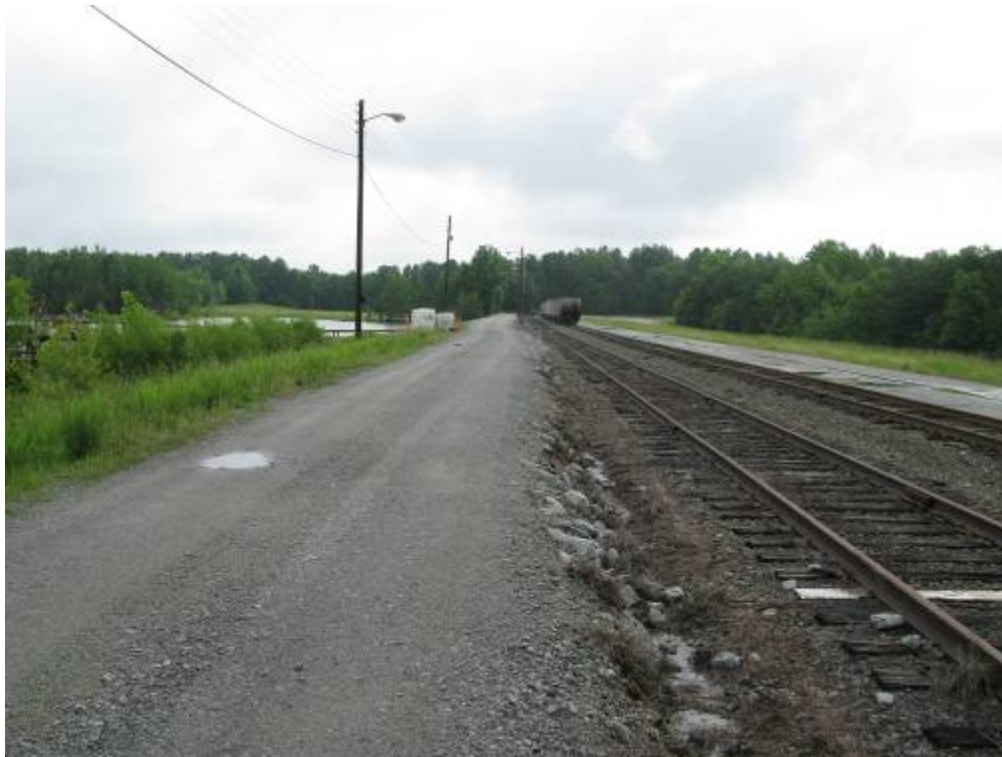
**Photo 6: View of crest road and rail tracks looking north**

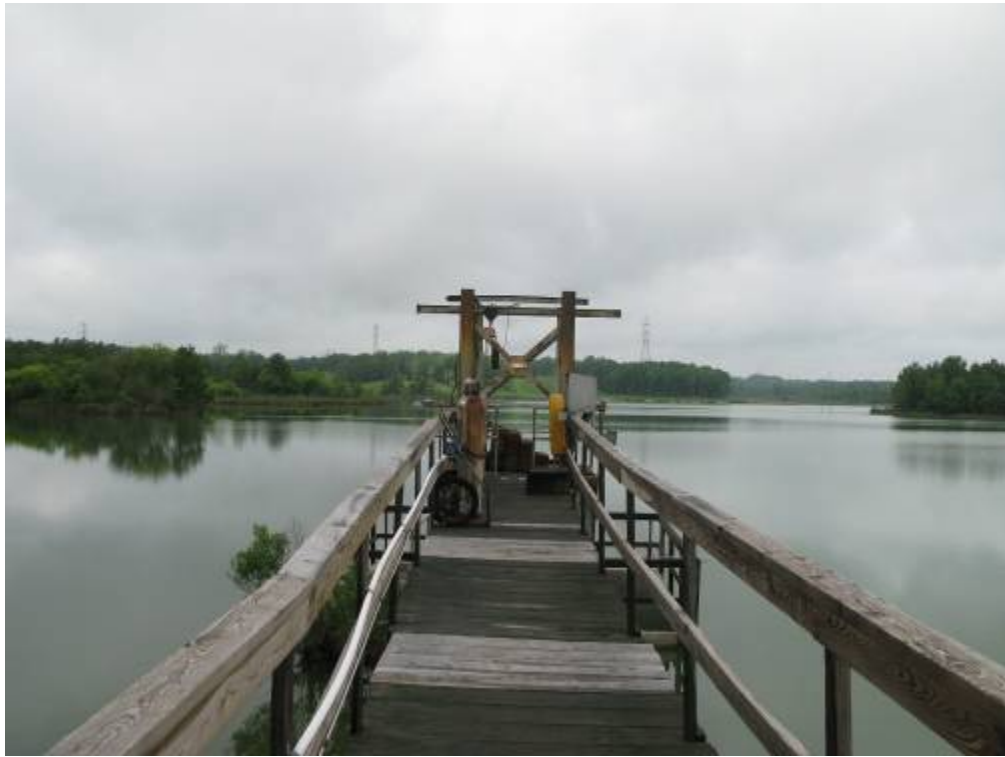
**Photo 7: View of walkway to Discharge Tower, with stoplog structure at the end of the walkway.**

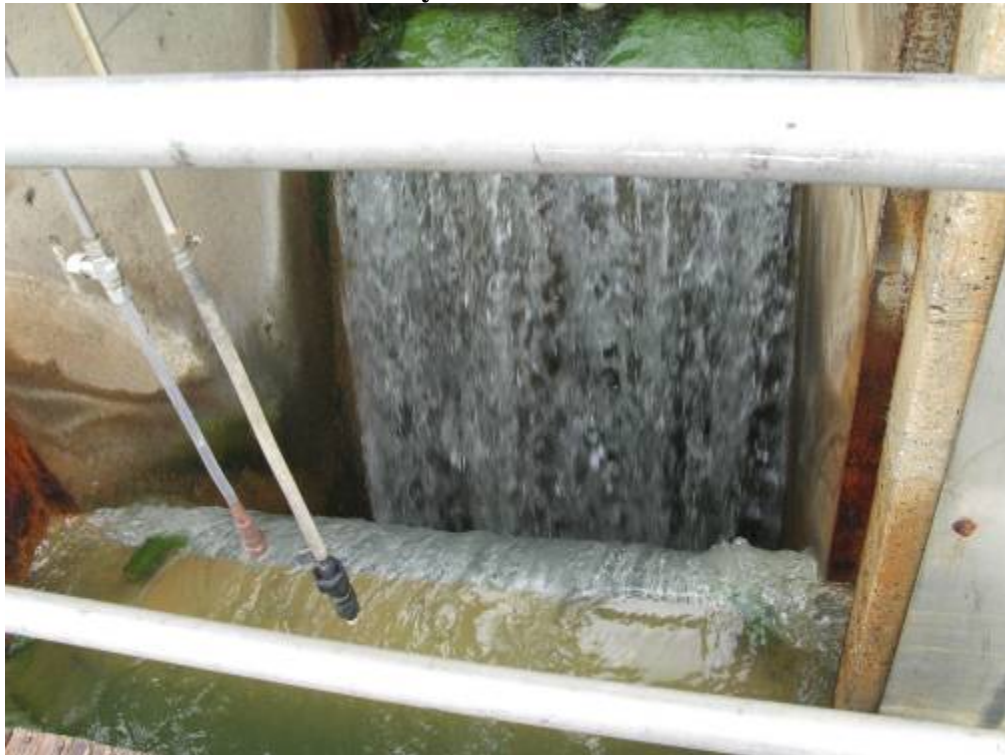
**Photo 8: View of water flowing over the stoplogs at the Discharge Tower. Pipes to left are used to add chemicals for pH correction.**

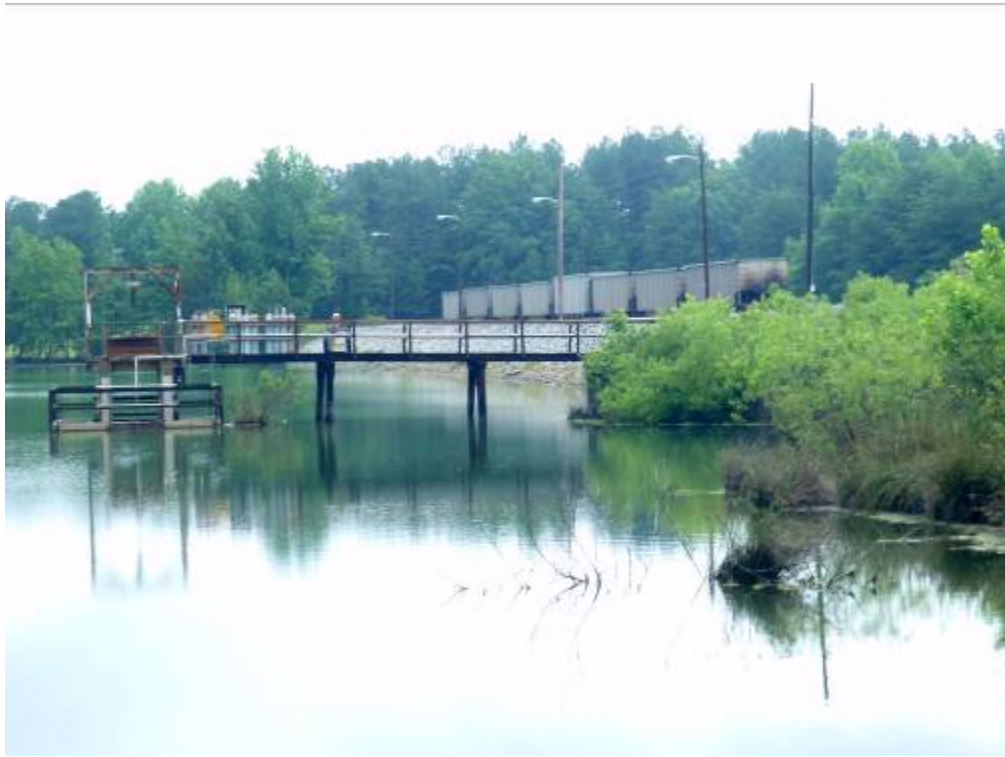
**Photo 9: Discharge Tower, looking north.**

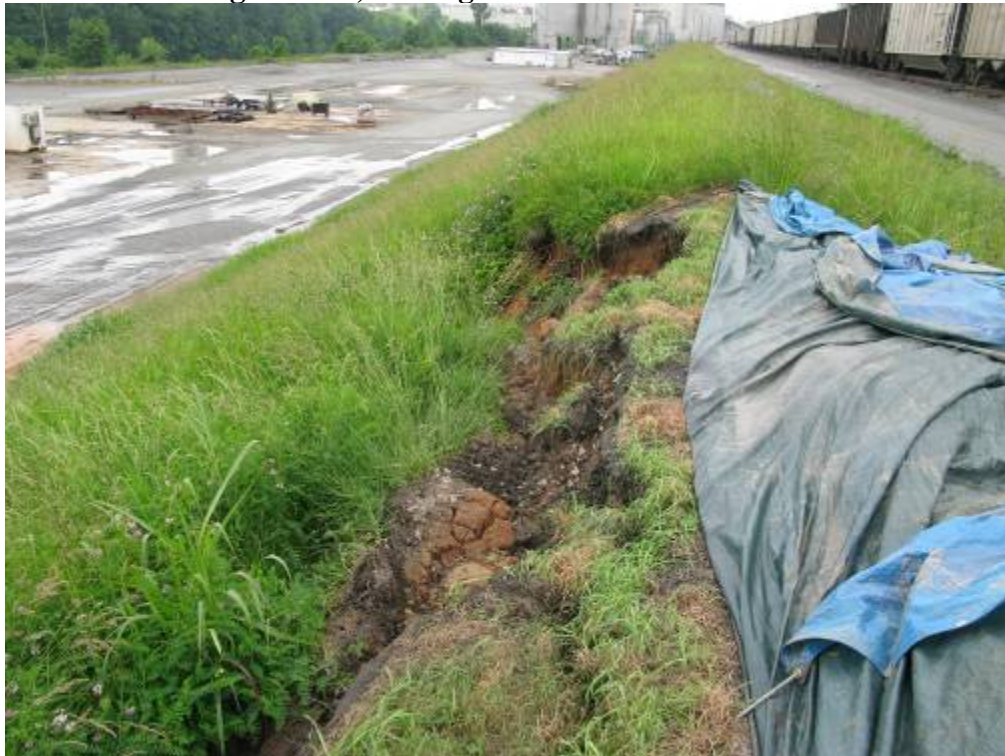
The slope was generally in good condition, except for at least five scarps that have formed near the crest. These scarps have formed at the crest, and appear to be due to localized slope failures due to the steep slope near the crest. The scarps vary in length from about 10 feet to 45 feet, and average about 3 feet in height. Duke Power has retained Mactec to design and oversee a localized repair for the scarps. The repair plan was reviewed during the inspection, and the design appeared adequate in GZA's opinion. However, the historical problems with surficial slope stability and the current presence of five scarps in need of repair raises the issue of whether a localized repair will provide a permanent solution, or whether further investigations are needed to evaluate the cause and provide a more permanent solution.

**Photo 10: Scarp on downstream slope at crest road, near the Discharge Tower. Lower berm on left.**

1. An updated stability analysis of the upstream and downstream embankment slopes including an analysis of shallow slope failure (especially for the as built upper downstream slopes, which appear steeper than 2H:1V) should be conducted after surveying the actual configuration of the slopes.

2. Duke Power has retained an outside consultant to provide an engineered repair of the scarps, but rather than approach this issue as an isolated repair, GZA recommends investigating the cause of the scarps more thoroughly (including but not necessarily limited to item 1 above).

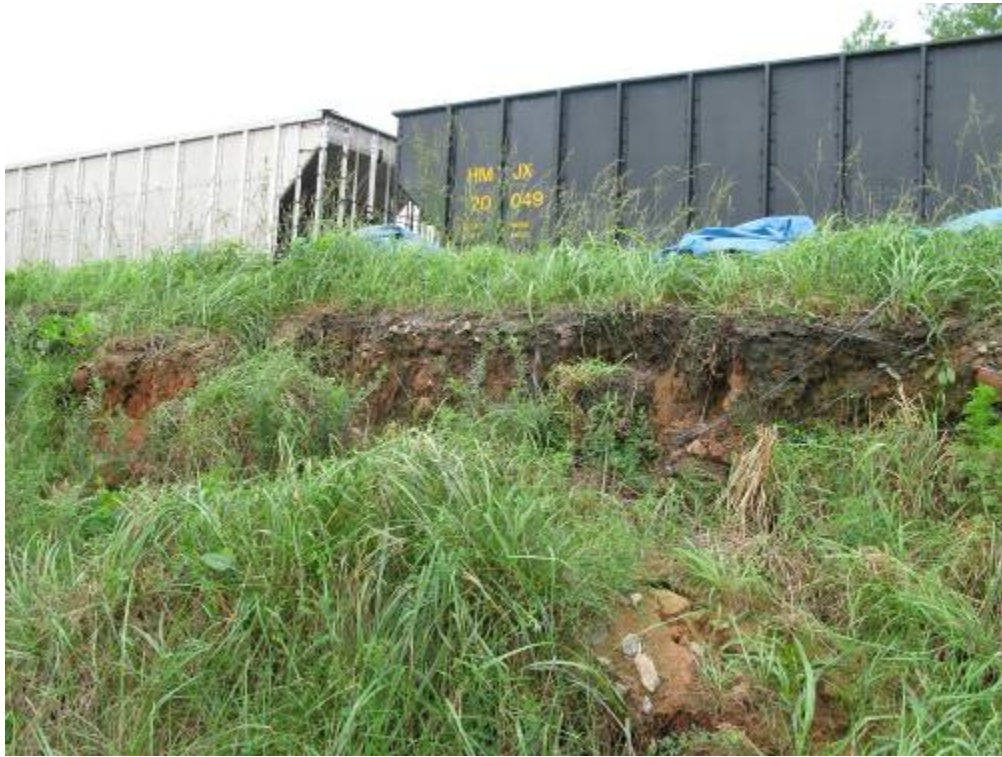
**Photo 11: Frontal view of scarp on downstream slope near the Discharge Tower.**

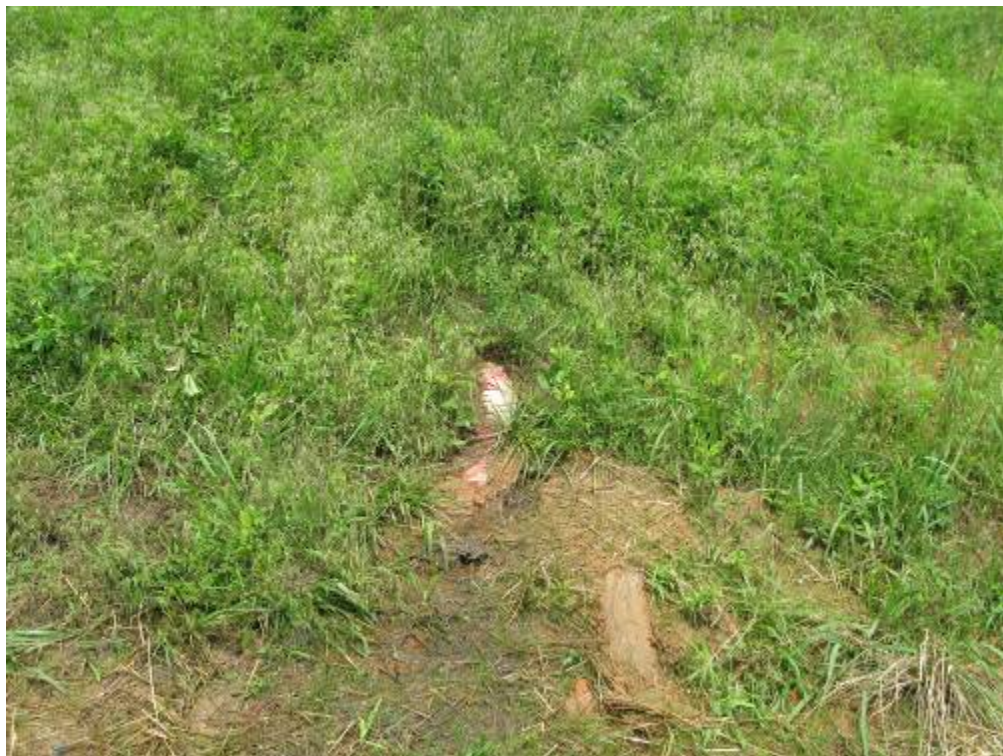
Possible seepage was observed flowing from the toe of the upper downstream slope approximately 500 feet south of the discharge canal. The seepage is just below a scarp, but appears to be related to a drain that extends from the crest that exits near the toe. A deltaic deposit of red soil, similar to the embankment material had formed on the berm. It is possible that this deposition is a result of surficial erosion in a scarped area immediately upslope. A large part of the toe was wet and spongy, but because of the heavy rainfall prior to the inspection, it is difficult to differentiate between seepage and surface water runoff. It appears that there are several local 6-8 inch CMP drain pipes embedded along the downstream face that transport runoff from the crest to the berm. Many of these drains were observed but it is believed that there are others which are buried.

**Photo 12: Seepage at base of upper downstream slope.**

3. Observations of the upper downstream toe should be made during periods of low rainfall to determine whether the wet and spongy conditions observed at the toe were due to surface water runoff or internal seepage. Further study should be conducted to correct the migration of dam core material that is being deposited on the berm.

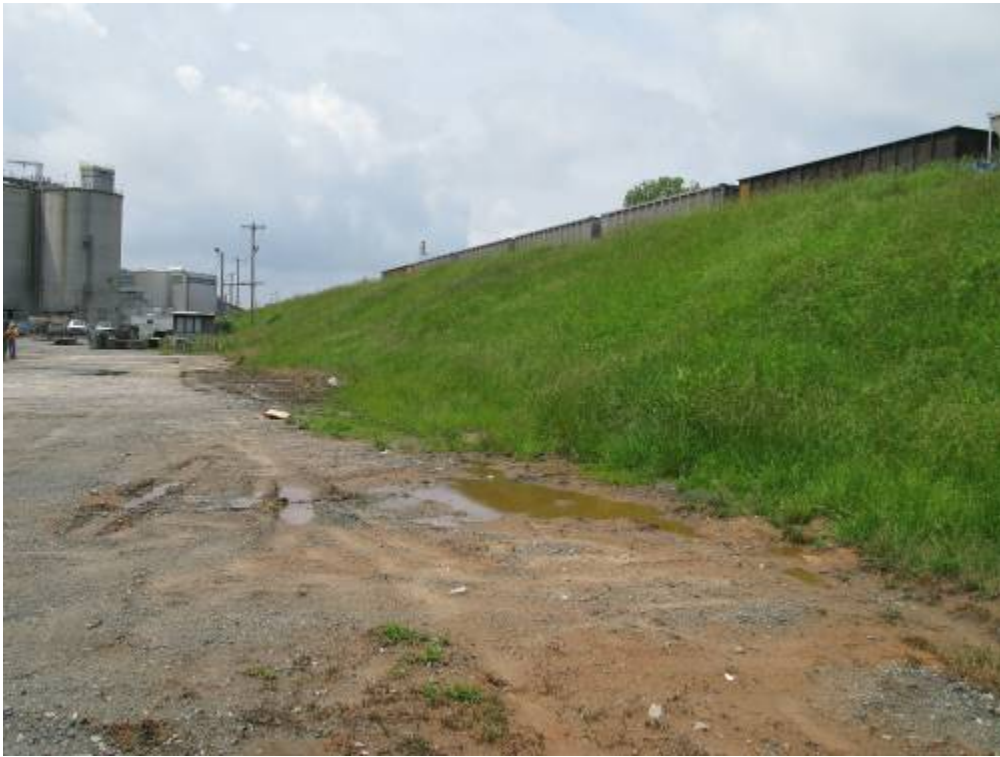
**Photo 13: Water at base of upper downstream slope.**

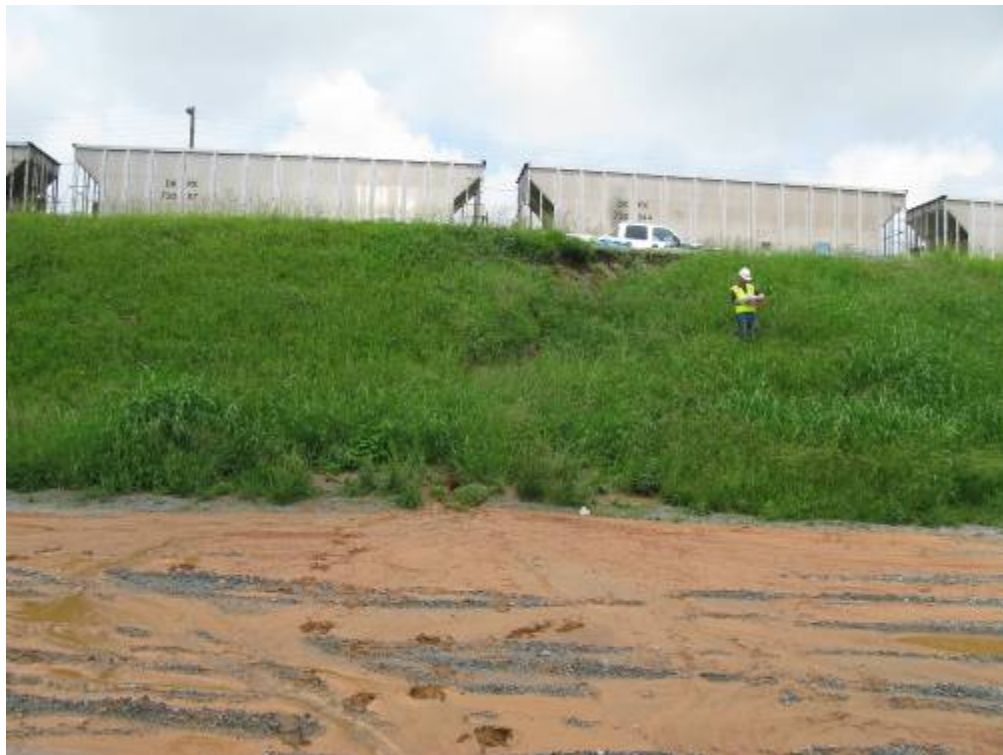
**Photo 14: Deltaic deposits at base of scarp. Note the surface erosional path from the crest to the berm**

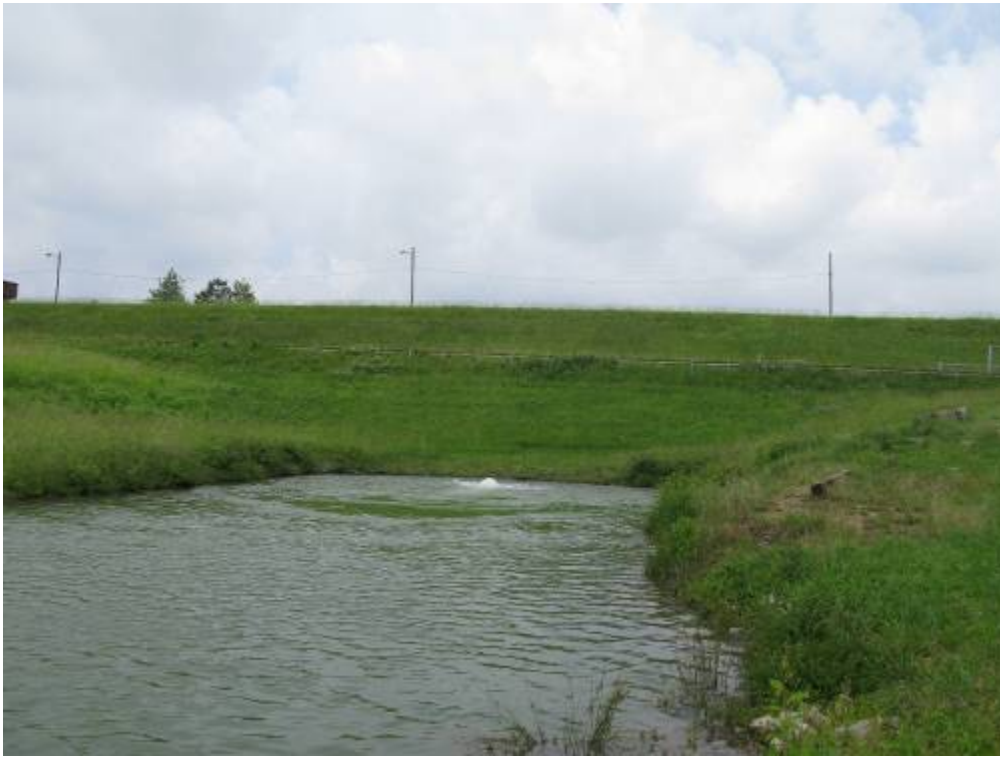
**Photo 15: Discharge canal. Note the water bubbling at the submerged discharge point.**

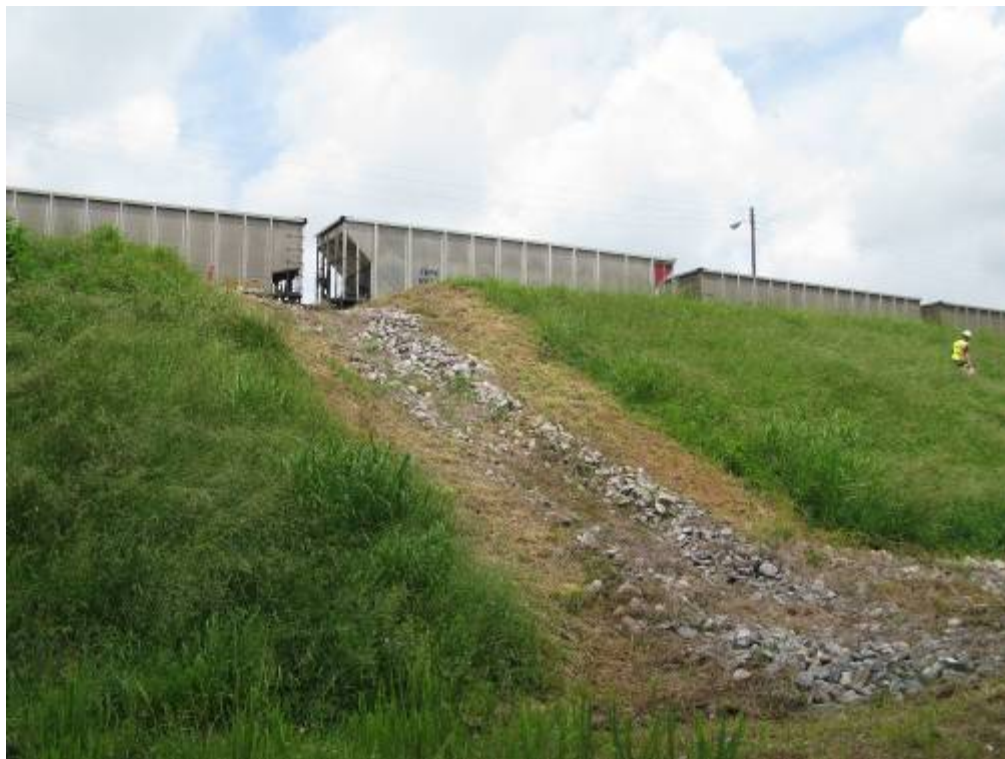
**Photo 16: Repaired scarp .**

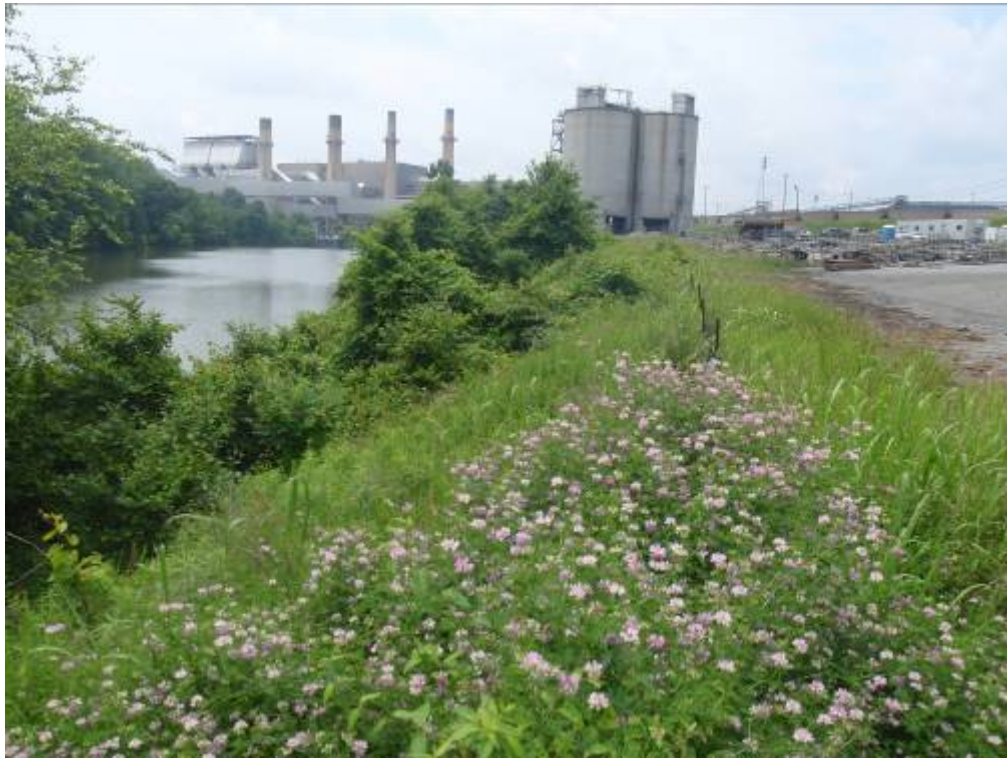
GZA attempted to inspect the lower downstream slope from the berm to Lake Norman however due to heavy vegetation and the steep slope our ability to do so was limited. In general the condition of this slope was found to be in poor condition. The vegetation on the slope is quite heavy with significant tree growth. There are several drainage swales cut into the berm that direct surface water to the lake. A large (approximately 8-foot) erosional hole was found near the scrap yard

**Photo 17: Downstream slope to Lake Norman. Note heavy vegetation near water line.**

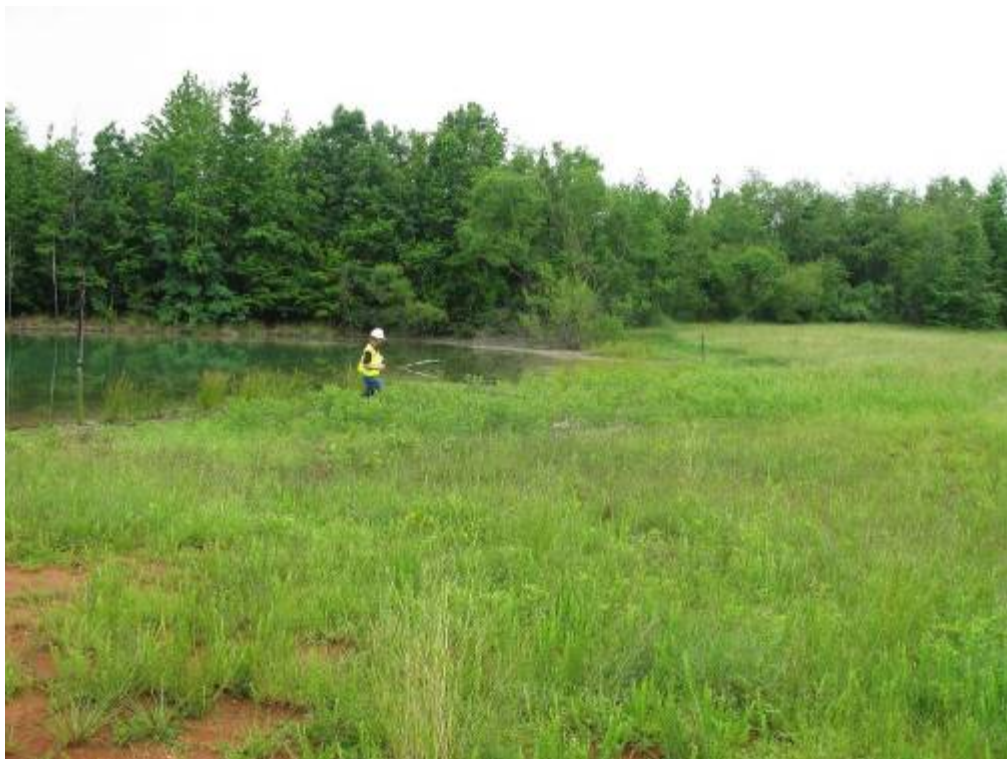
**Photo 18: Emergency Spillway**

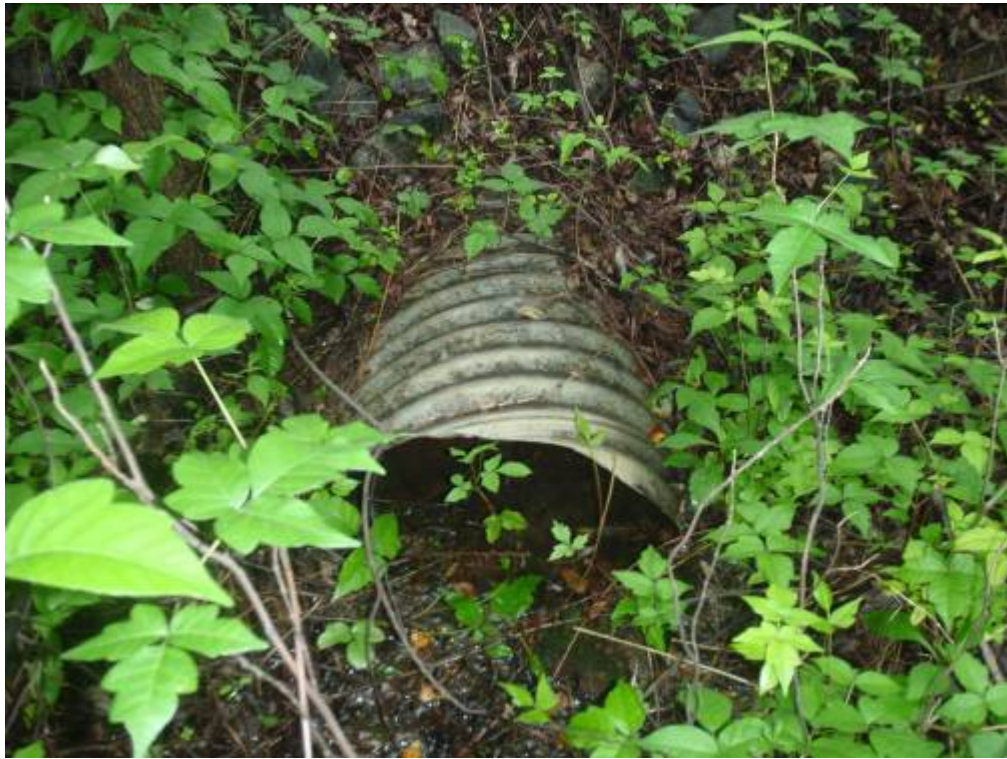
Two drainage outlets were located at the toe of the northern (left) section of the downstream embankment. A relatively new precast concrete discharge structure was located downstream of the new riprap chute constructed between poles 45 and 46. There was no flow or debris in this structure. An older 36-inch diameter CMP drain was located at the toe of slope downstream of a hole exposing a 20-inch vertical CMP observed on the crest of the dam. This pipe was silted in to approximately 6 inches below the crown but still had roughly 2 gallons per minute (gpm) of clear flow discharging through it (Photo No. 19).

**Photo 19: Old 36-inch CMP drain outlet at Toe of the Downstream Slope of the Northern Embankment.**

4. Surface grading and the extent and condition of the drainage system (including video camera survey of pipe interiors and related drainage infrastructure where appropriate) at and adjacent to the dam should be evaluated.

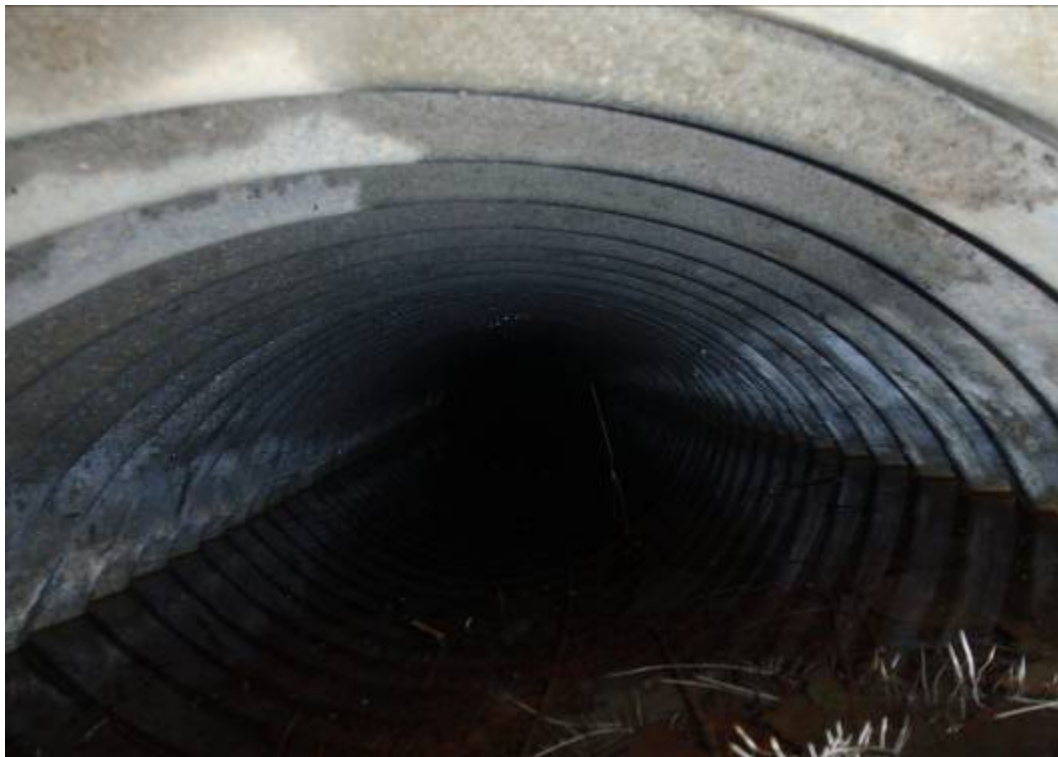
**Photo 20: Interior of Old 36-Inch Diameter CMP Drain Located at the Toe of the Downstream Slope.**
